MOUNT GREYLOCK STATE RESERVATION  
LANESBOROUGH, MASSACHUSETTS

23 June 2007

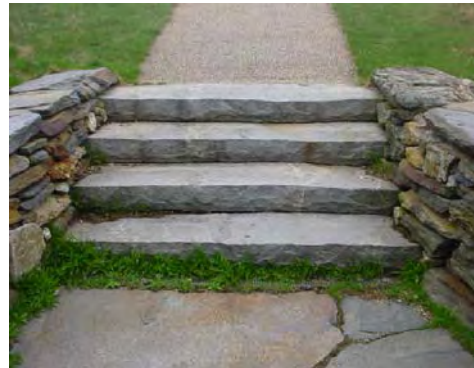
Figure 4. Site stairs.

The building is located at on the southern side of the summit of Mount Greylock in the Mount Greylock State Reservation. The lodge is part of the Mount Greylock Summit Historic District. The area around Bascom Lodge was surveyed by Accord Engineering and Surveying Inc. in 1997. A series of paved paths and wear paths (Figure 2) connect the lodge, parking areas, trails, and the other summit buildings. There is a small paved parking area to the west of the building that accommodates handicap parking (Figure 3). The area around the building is sloped from north to south. A stone retaining wall transitions the grassy slope to the north of the building to the stone patio in front of the central entrance. A set of granite stairs in the stone retaining wall provides access from the path to the War Memorial to the central entrance (Figure 4).

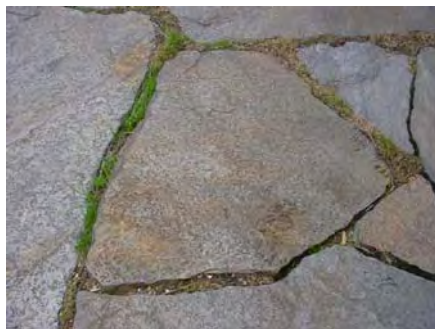
Figure 7. Well cover under flagstone patio.

The patio to the north of the central entrance is made of dry-laid flag stones. One stone camouflages the metal well cover below (Figure 7). Several metal covers are located adjacent to the south side of the lodge; three holes in the drive access the 10,000 gallon concrete septic tank and two holes near the kitchen stair access the 1,000 gallon grease trap.

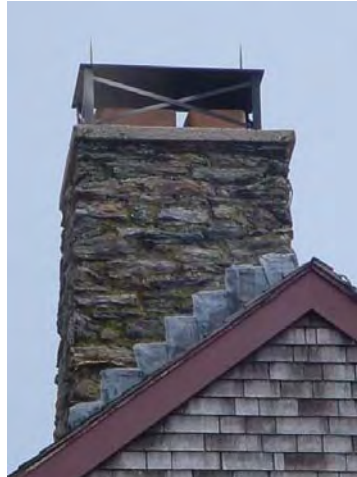
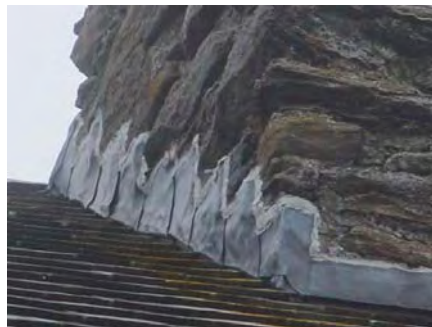
There are three chimneys; a chimney serving the central block and two end wall chimneys, one on each wing. The step flashing material used to flash around the chimney and along the slope of a roof appears to be lead. (Figures 20 & 21) Only the central chimney is capped and lined. The chimneys are in fair condition, however the step flashing around the chimneys is in poor condition and there is internal evidence of leaking at all three chimneys.

- Repoint all mortar joints.
- The chimney, flues, fireboxes and cleanouts should all be inspected and cleaned by a certified chimney sweep or mason.

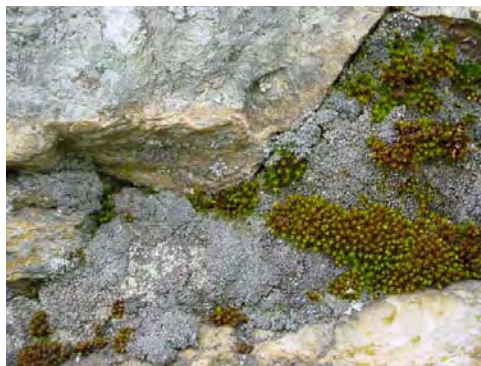
Figure 22. Lichen growth on stone walls.

The locally quarried stone walls are laid in a random pattern with wide mortar joints. The majority of the stone walls have tight uncracked mortar joints. Mosses and lichens have developed on the walls (Figure 22). There are some noticable cracks on the north elevation beneath the stone sills (Figure 23) and beneath the wood bracket (Figure 24).

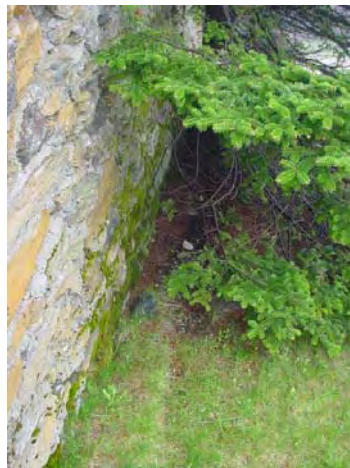
Figure 27. Organic growth on walls.

There are few plantings around the perimeter of the building. However a evergreen tree on the south side of the west wing is located too close to the exterior walls. The branches are holding moisture close to the wall and encouraging organic growth on the wall surface. (Figure 27).

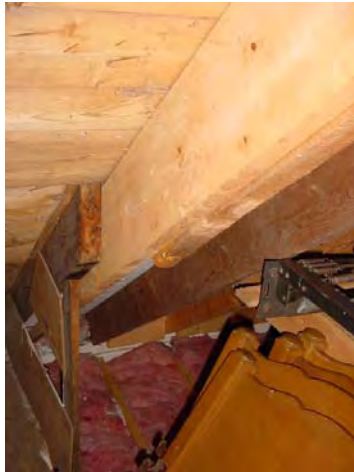
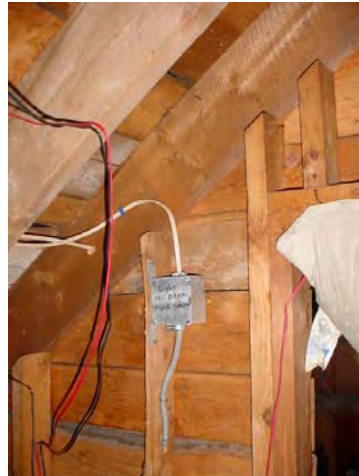
The roof of the western wing and a portion of the east wing over the kitchen are framed with 2"x8" rafters at 16 inches-on-center with 2"x6" collar ties and tied to 2"x8" floor joists (Figure 28 & 29). Modifications to the typical framing system were made in 1980 when the public bathrooms were modified below. All the framing in these areas appear to be in good condition and meets code requirements.

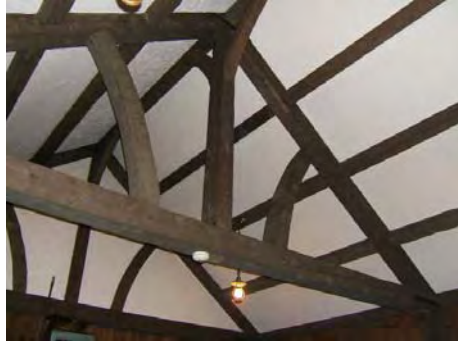
Figure 30. Dining room trusses.

The roof framing over the dining room in the east wing is framed by exposed timber framing with mortise and tenon joinery (Figure 30). The trusses have curved web timbers and a 5"x5" vertical member. 4"x5" roof purlins are spaced evenly between the 7"x7" timber top chords of the trusses. The top chord of the trusses has significant checking along the longitudinal axis. Preventive measures should be undertaken to prevent further checking by reinforcing the members.

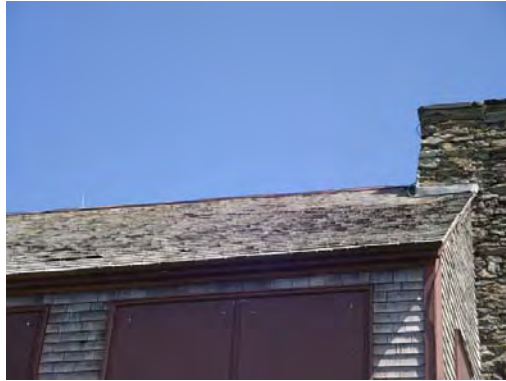
Figure 34. Wood roof shingles

The building is covered with wood roofing shingles. The roofing shingles are in poor condition on the south side of the building with evidence of curling, lifting, and loose shingles (Figure 34). The roofing shingles are in fair condition on the north side of the building with some evidence of staining (Figure 35); probably from the initial water runoff over both the existing fire retardant cedar.

- Replace wood roofing shingles with new treated wood roofing shingles.
- Replace aluminum flashing with new, preferably lead coated copper or zinc, flashing at all locations. DO NOT use un-coated copper flashing with cedar shingles.
- Replace flashing over the doors and windows.
- Re-grade around the exterior of the building to allow water runoff from the roof to drain away from the foundation. Install a crushed stone drip edge.

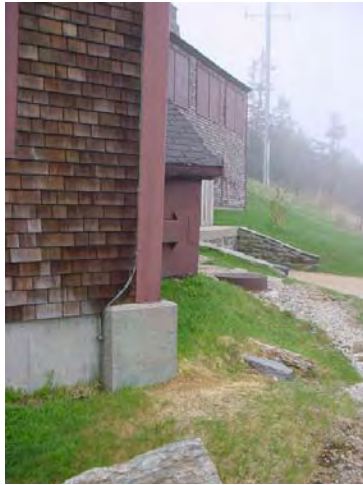
Figure 37. Site below missing spout.

There are gutters on the south side of the central gable roof and the south facing shed dormer. There is one downspout for each gutter. The main downspout from the porch roof is missing (Figure 36). The turf beneath the downspout is worn and eroding (Figure 37). There are no gutters on the remaining roofs. There is some evidence of splashback onto the bottom courses of the stone and wood shingle walls, as well as a pronounced drip edge adjacent to the north elevation of the east wing.

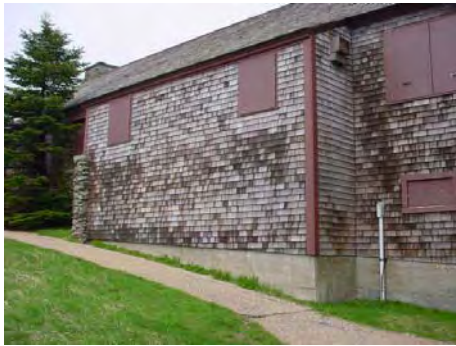
Figure 39. Wet shingles.

The south elevation and upper sections of the north elevation are clad in natural cedar shingles. The siding is in fair condition. During fog and early morning hours, the shingles were wet (Figure 39). The surface of the wood shingles dried naturally by late afternoon after fog and clouds had cleared. Some of the shingles have mold growth on the surface. The unexposed surfaces of the shingles maybe wet for extended periods. A narrow airspace behind the cedar shingles would facilitate the natural drying of the shingles and the sheathing beneath and extend the life of the siding.

- Provide new exterior wood shingles. Provide airspace behind shingles to facilitate drying.

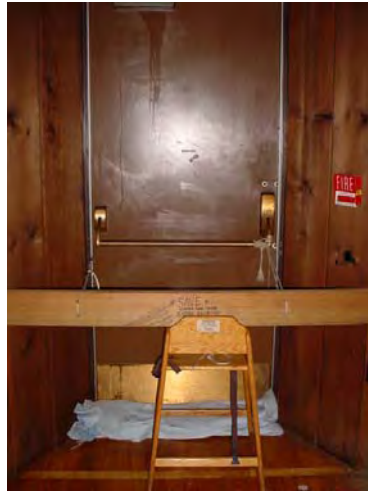
Figure 44. Dining room exit door.

There is one door on the east side of the building that provides access to the dining hall (Figure 44). The solid metal door has a closer and panic hardware. A towel at the bottom of the door and staining on the wood floor indicates that the door frequently leaks. The door is protected on the exterior by a plywood panel.

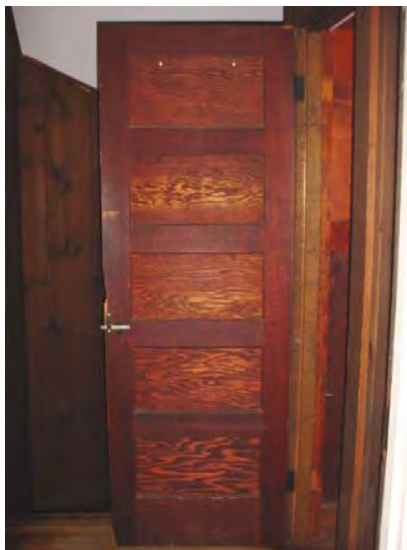
Figure 49. Original 5-panel door finish

Older, probably original, interior doors are wood five-panel doors located on the second floor. These wood doors are in good condition, even though most of the doors have been painted white (Figure 50). One five-panel door leading to the attic over the east wing has retained its original dark wood finish (Figure 49).

- Retain historic interior French doors. Maintain historic hardware. Scrape and paint.
- Existing interior five-panel doors should be retained and repaired as necessary. Provide new lever hardware.

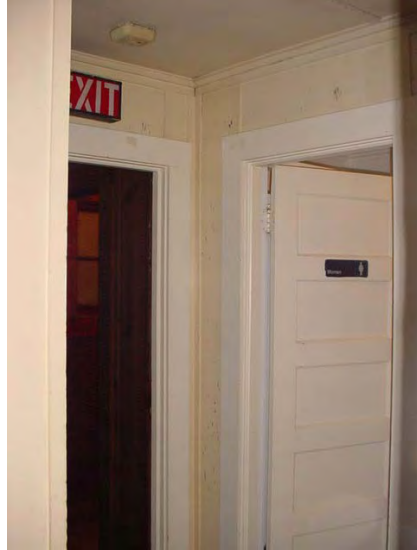
Figure 50. Painted 5-panel door.

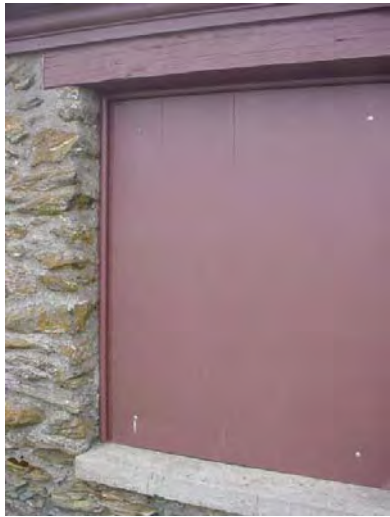
Figure 51. Protected windows

The exterior of the windows on the first floor were not visible due to the external protection panels (Figure 51). Portions of the stone sills were visible and are in good condition. The upper and lower sashes of each double hung unit have been opened to the mid-point. The position of the window sashes accommodates for some internal ventilation. The painted plywood protection panels are anchored by thru-bolts to horizontal bracing cut from dimensional lumber at the interior face of the head and sill (Figure 52 & 53). The protection panels were designed as recommended by the *National Park Service* to protect the windows when the lodge is not in use. This system probably works well during the cooler months when the building is not normally in use. However there does not appear to be enough interior ventilation during the warmer humid months when the lodge would normally be open. The increased levels of humidity and high summer temperatures combined with the insufficient ventilation are ideal conditions for mold growth. There was significant mold growth between the team's May and June field visit.

- Exterior historic storm/screen panels should be installed to protect the historic materials, guard against vandalism, reduce air loss, and improve the energy efficiency of the building. The plywood protection panels should continue to be used in conjunction with the storm panels in the off-season.

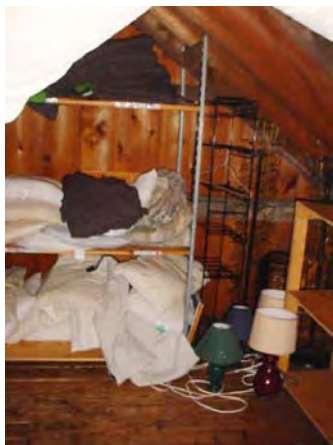
Figure 59. Attic linen storage.

The mattresses in attic are a fire hazard, as well as material for moisture retention. The mattresses and linens should be removed or stored carefully to prevent mold growth.

- Remove spare materials and furnishings.

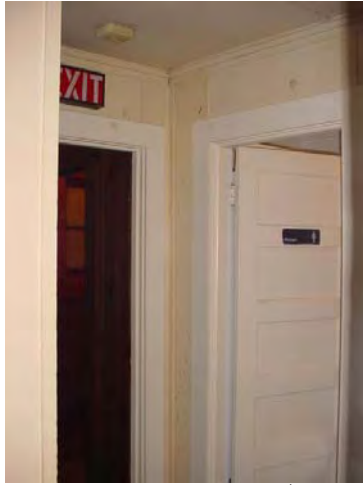
Figure 63. Painted trim-2<sup>nd</sup> floor.

- Restore natural wood finish to second floor paneling, trim, and doors.
- Replace kitchen and bathroom casework in basement apartment.

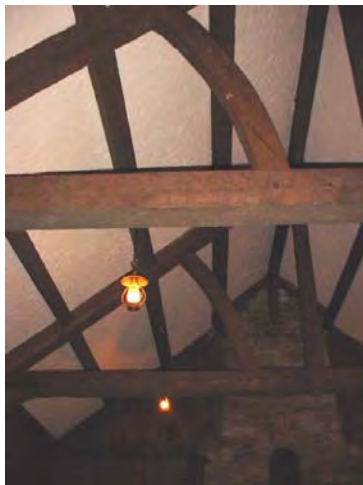
Figure 65. Textured ceiling.

The ceilings are primarily gypsum wall board, except in the main hall and dining room. The dining room has a textured plaster ceiling. The substrate for the plaster was not visible in the attic. There is some flaking paint. There is a moderate amount of deterioration of the gypsum ceilings at areas where leaking has occurred, including the western lounge (Figure 66) and the ADA bathroom. There is a moderate amount of flaking paint, evidence of excessive moisture, in the public restrooms, the ADA bathroom, in the second floor bathrooms, and in the apartment bathroom. There is minor flaking paint in the remainder of the basement apartment.

- Remove loose flaking paint, repair minor cracks, skim coat as required and provide a smooth surface for finish painting.
- Provide additional ventilation in bathrooms and restrooms. Use only moisture-resistant gypsum wallboard in bathrooms and restrooms.

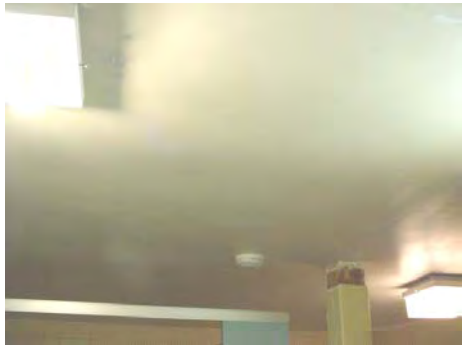
Figure 67. Bathroom ceiling.

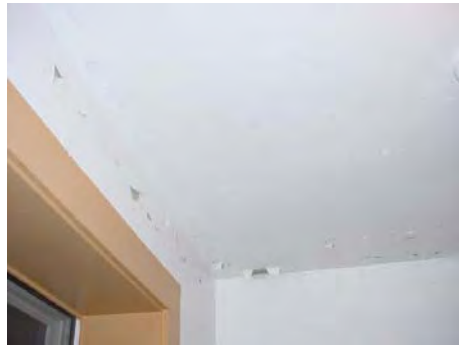
Figure 68. Drywall ceiling.

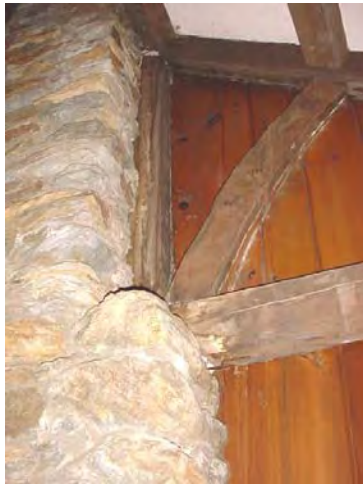
Figure 69. Dining room southeast wall.

The walls are primarily gypsum wall board, except in the main hall and dining room. The dining room and main hall have a vertical board finish that is described in *Interior Wood Trim & Case Work* above. The vertical board paneling is around the chimneys is damaged from leaking (Figure 69: East Chimney) and from graffiti. There is also missing mortar at the junction of the main chimney and the wall paneling (Figure 70).

- Remove loose flaking paint, repair minor cracks, skim coat as required and provide a smooth surface for finish painting.
- Provide additional ventilation in bathrooms and restrooms. Use only Moisture-resistant gypsum wallboard in bathrooms and restrooms.
- Repair damaged paneling on east and south walls of the dining room.

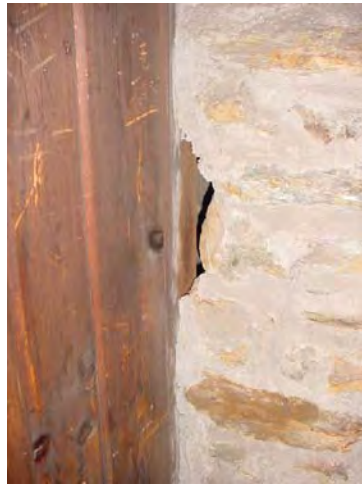
Figure 70. Paneling and stonewalls.

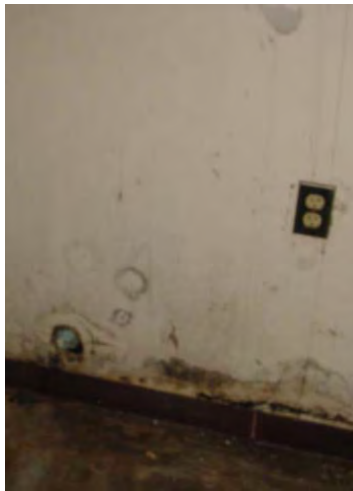
Figure 71. Moldy drywall in basement.

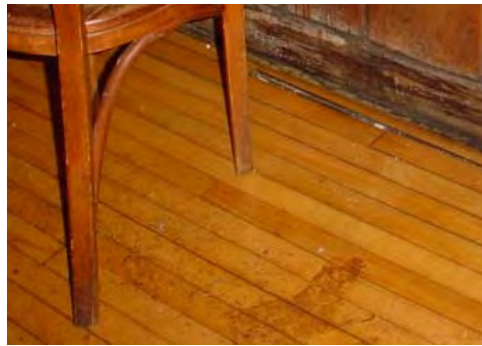
Figure 74. Stained wood floor.

The flooring in the lodge is primarily narrow wood strip flooring. The wood strip flooring is extant in the dining room, all lodging rooms, and the attic closet on the east wing. The wood strip flooring is generally in good condition with some minor areas of deterioration from leaks around windows, doors, and at areas of previous removals (Figures 74 & 76).

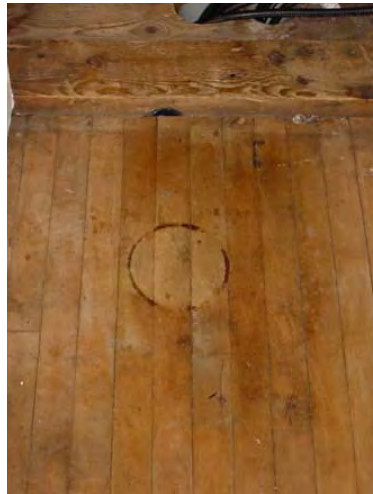
Figure 76. Floor shadows.

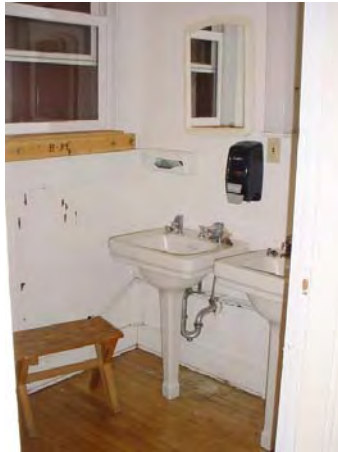
Figure 77. Women's room sinks.

The plumbing system has been amended over the years during the reconstruction of the west wing bathroom in 1980, again for the addition of the basement apartment and the rehabilitation of the kitchen in 1988, and in 1997 for the addition of four shower rooms on the second floor. There are no apparent leaks in the system, although there is evidence of damage to flooring and wall finishes from condensation near the base of toilets and sinks. Some of the oldest bathroom fixtures are in need of replacement, but most of the fixtures are serviceable (Figure 77 & 78).

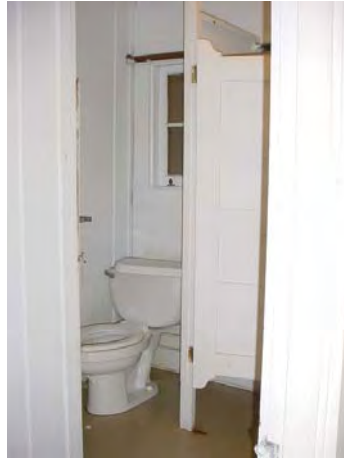
Figure 78. Men's room toilet stall.

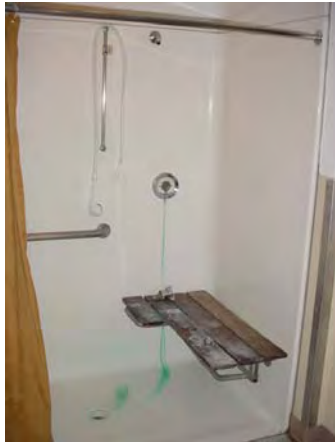
Figure 79. ADA roll-in shower.

The ADA bathroom in the west wing of the first floor is in fair condition. The roll-in shower is in good condition (Figure 79) and in need of a cleaning. The sink and toilet do not meet current ADA standards and should be replaced.

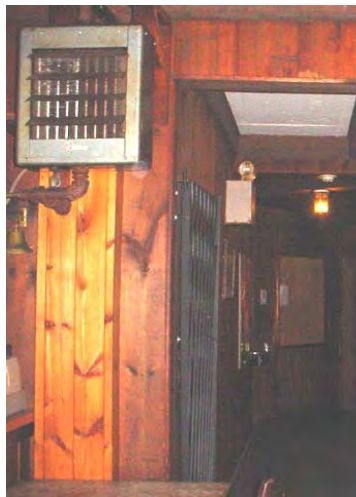
Figure 82. Dining room heater.

The existing heating system is a one pipe steam system supplied to cast iron radiators in most of the first and second floor living spaces. The dining room has a horizontal unit heater (Figure 82). The piping is insulated and the insulation has signs that it contains asbestos.
